A Brief Summary of the National River Restoration Science Synthesis (NRRSS)

The Kissimmee River Restoration Project

Restoration of the Kissimmee River.

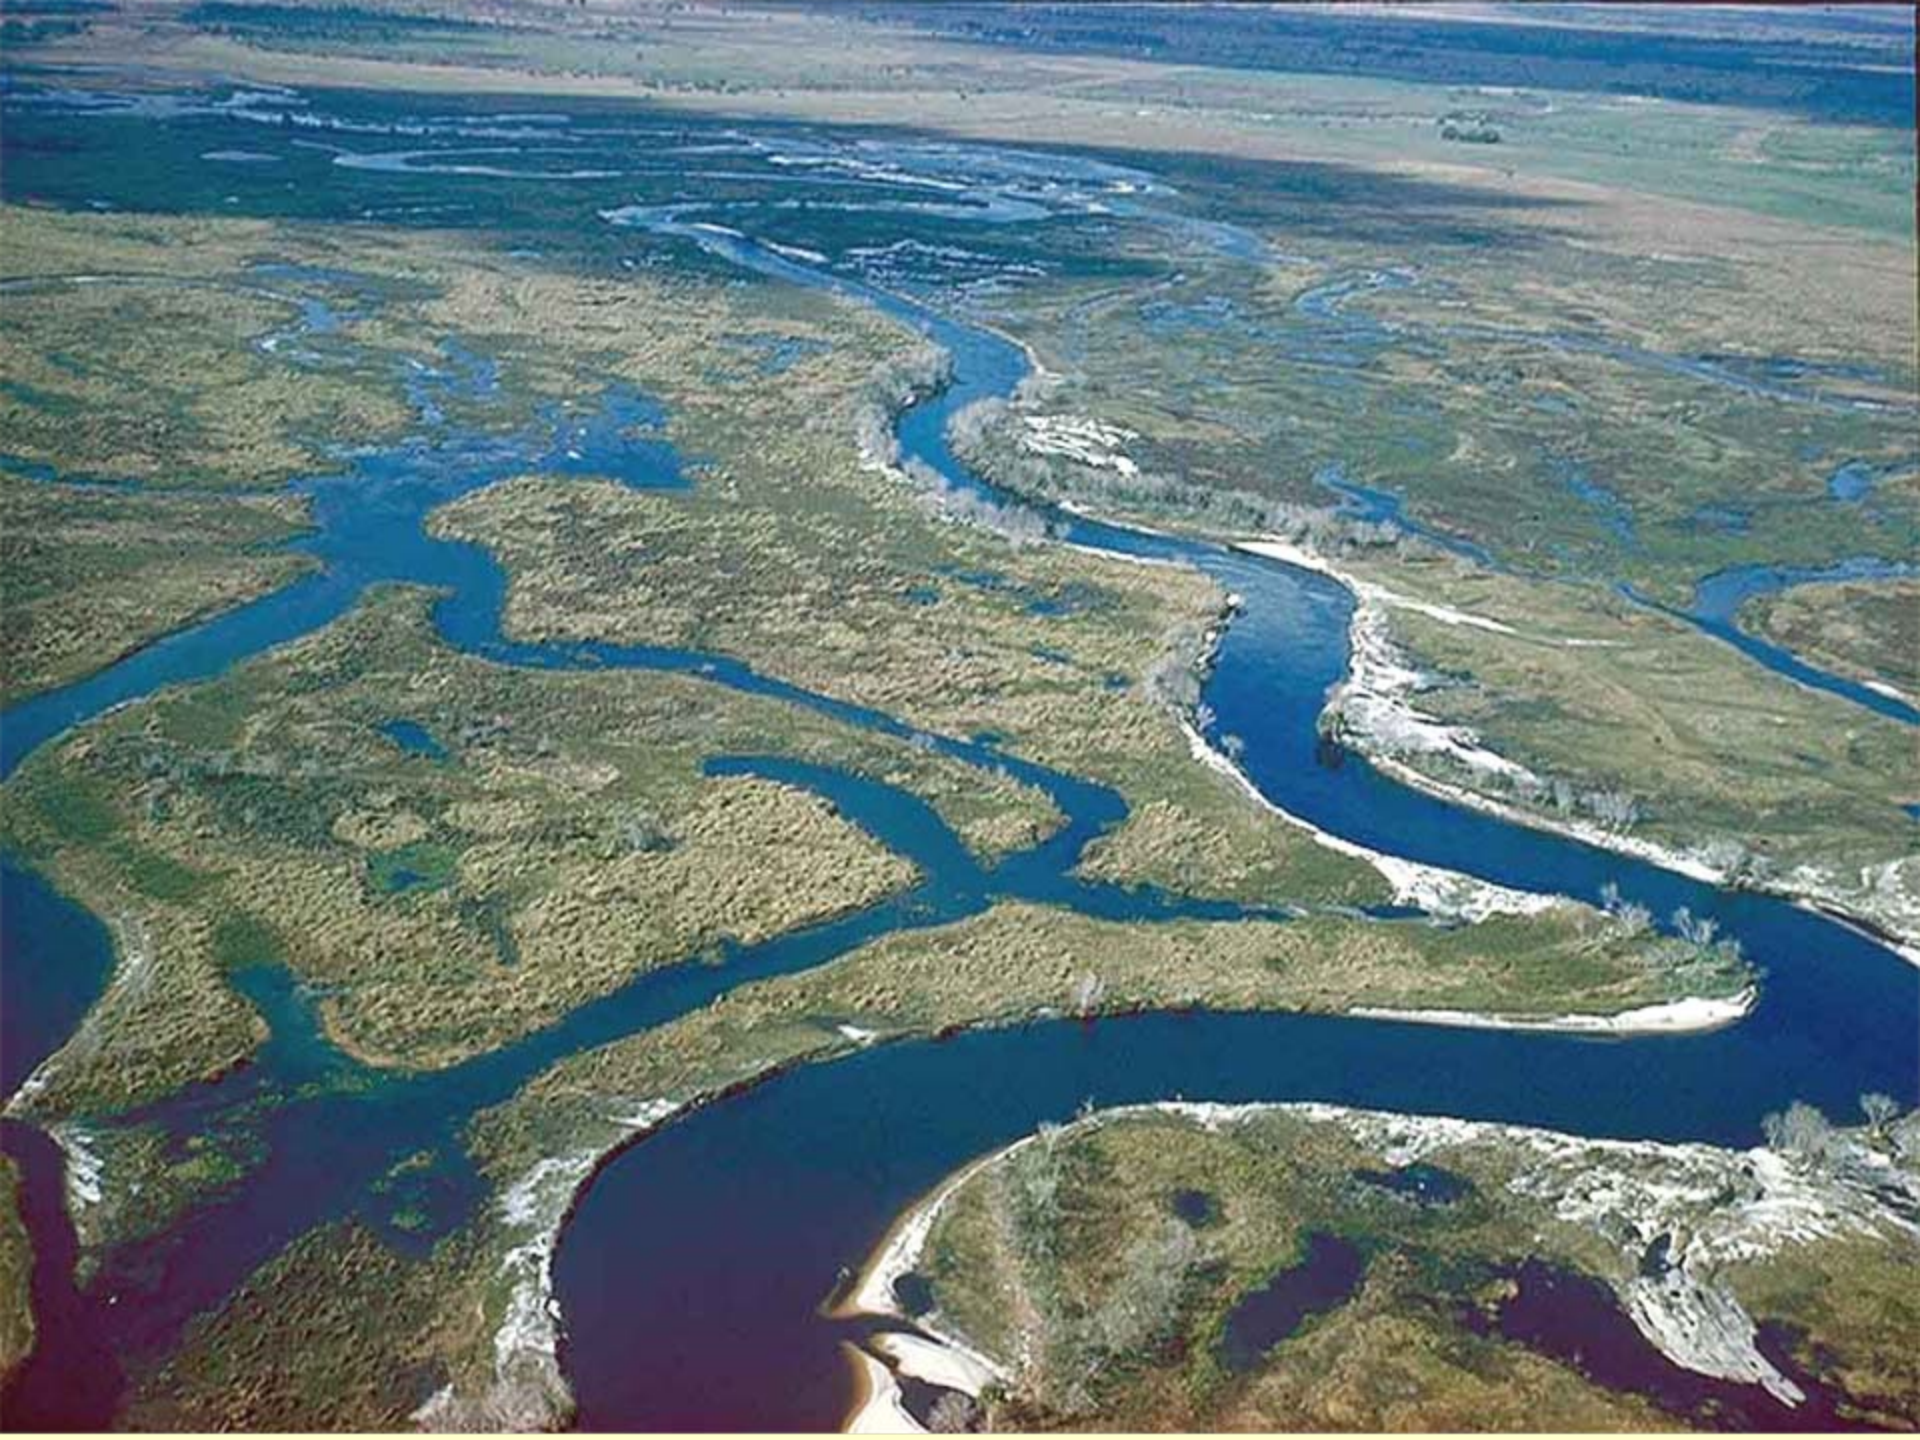
An aerial photograph showing a straight canal (C-38) running vertically on the left side of the frame. To the right of the canal, a winding, meandering river channel is visible, surrounded by dense green vegetation. The landscape is a mix of green fields and forested areas. In the upper right, there's a small area of cleared land with some structures. The sky is visible at the top, showing some clouds.

**C-38 Canal and remnant Kissimmee River,
post channelization circa 1980**

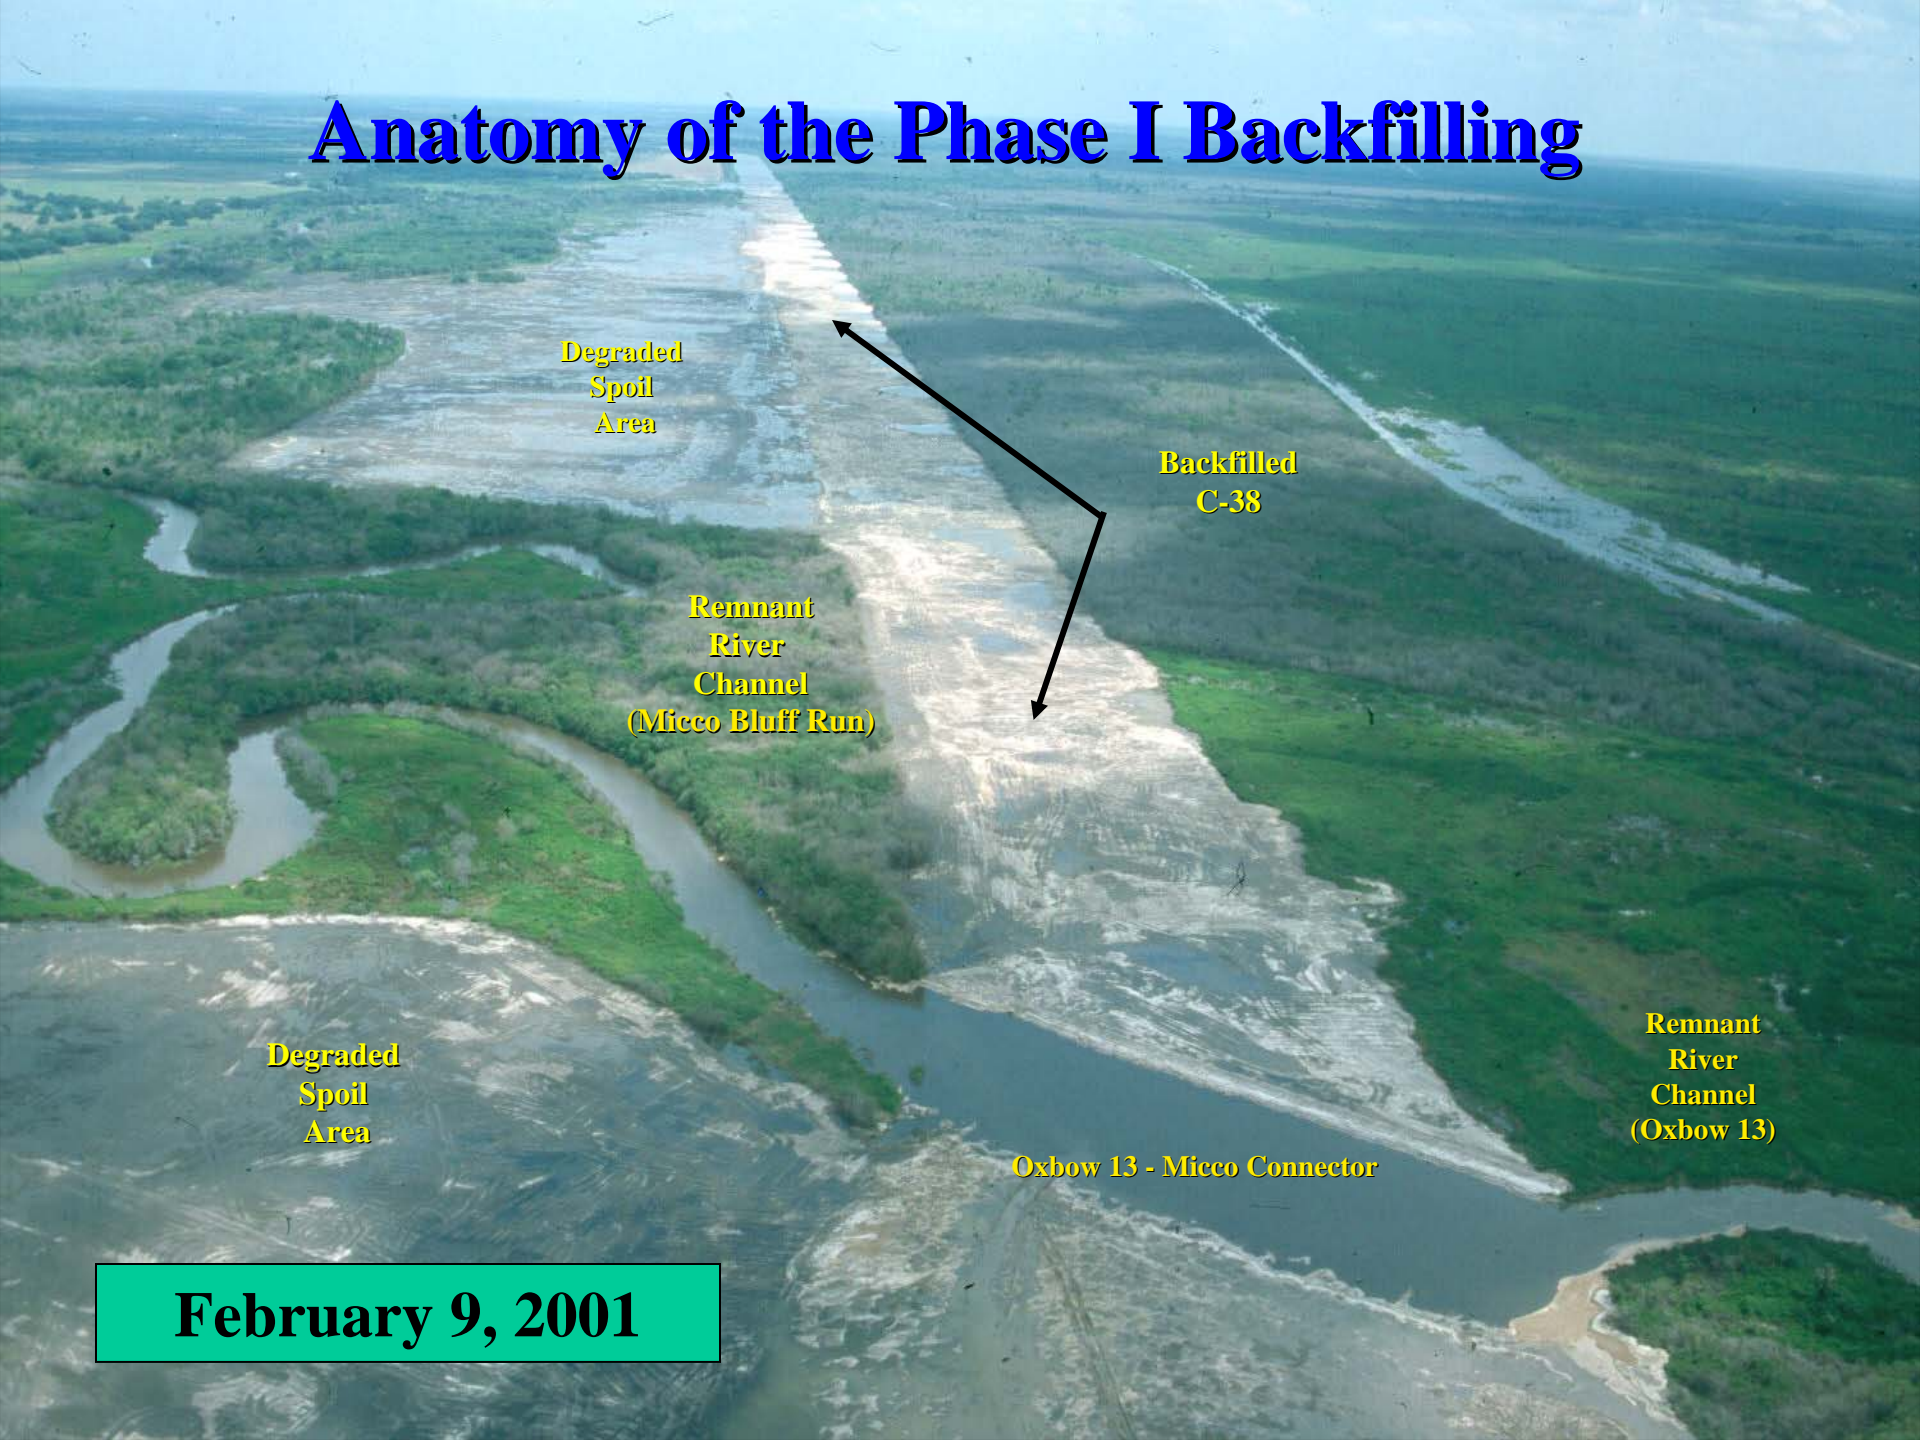
Anatomy of the Phase I Backfilling

Degraded
Spoil
Area

Backfilled
C-38

Remnant
River
Channel
(Micco Bluff Run)

Remnant
River
Channel
(Oxbow 13)
